**JOHNSON VILLAGE WASTEWATER
POST JULY 2023 FLOOD
TREATMENT PLANT ASSESSMENT
LAMOILLE COUNTY, VERMONT**

**NPDES PERMIT NUMBER VT0100901
STATE OF VERMONT PERMIT NUMBER 3-1149**

August 9, 2023

This report was prepared based on observations made during July 13th, 17th and 18th site visits by Heather Collins, VT DEC, WSMD, WWMP in conjunction with Army Corps of Engineers and US EPA Region 1 representatives.

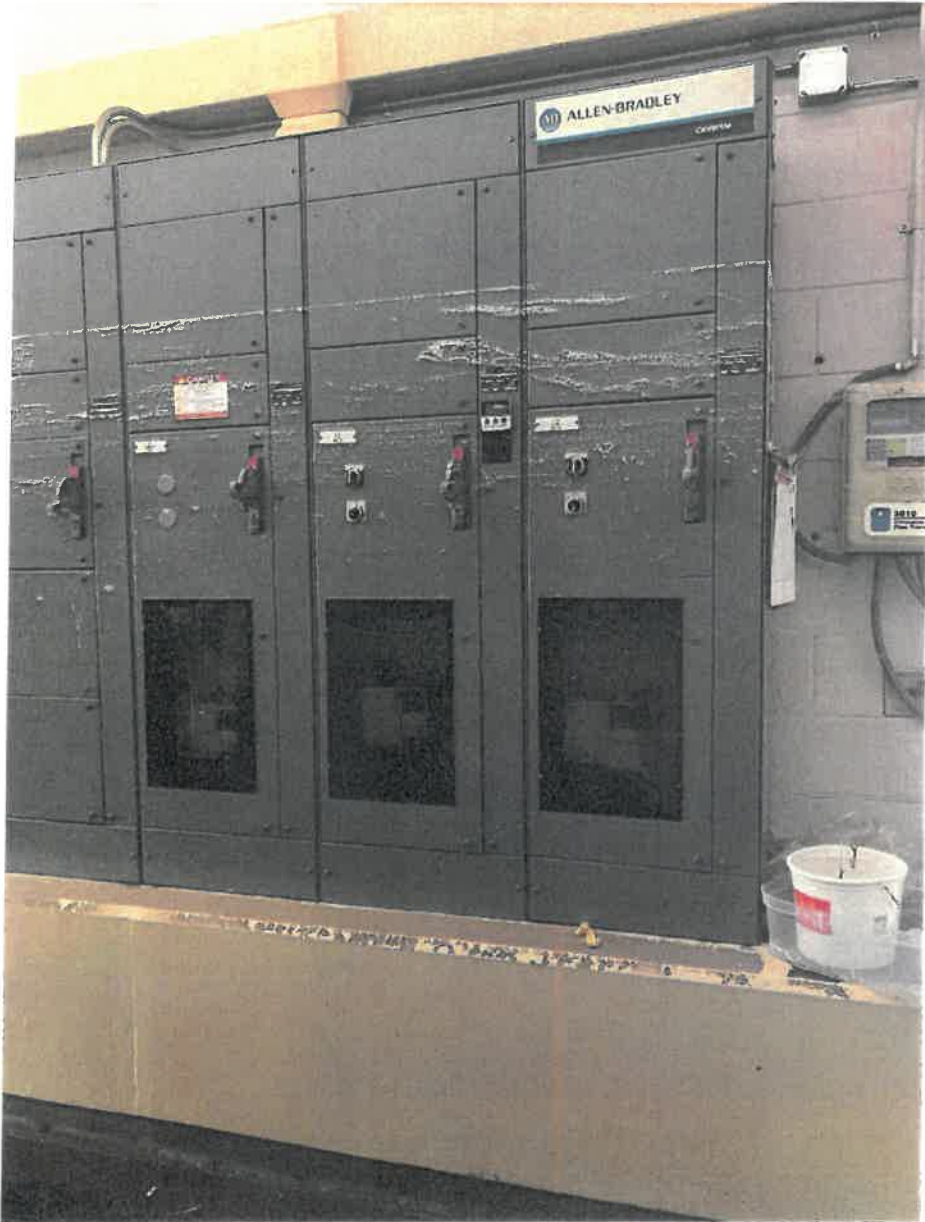
The motor control center (MCC) including nearly all pump and motor starters, variable frequency drives (VFDs), branch circuit breakers, and electrical conduits were inundated and likely destroyed. The same is true for the plant's heating and hot water system, meters, analytical monitors, recorders, laboratory equipment and supplies, and automatic samplers. The UV system is obsolete and repair parts are not able to be sourced. It is likely a complete loss. The plant's automatic transfer

1 - High Water Mark on MCC

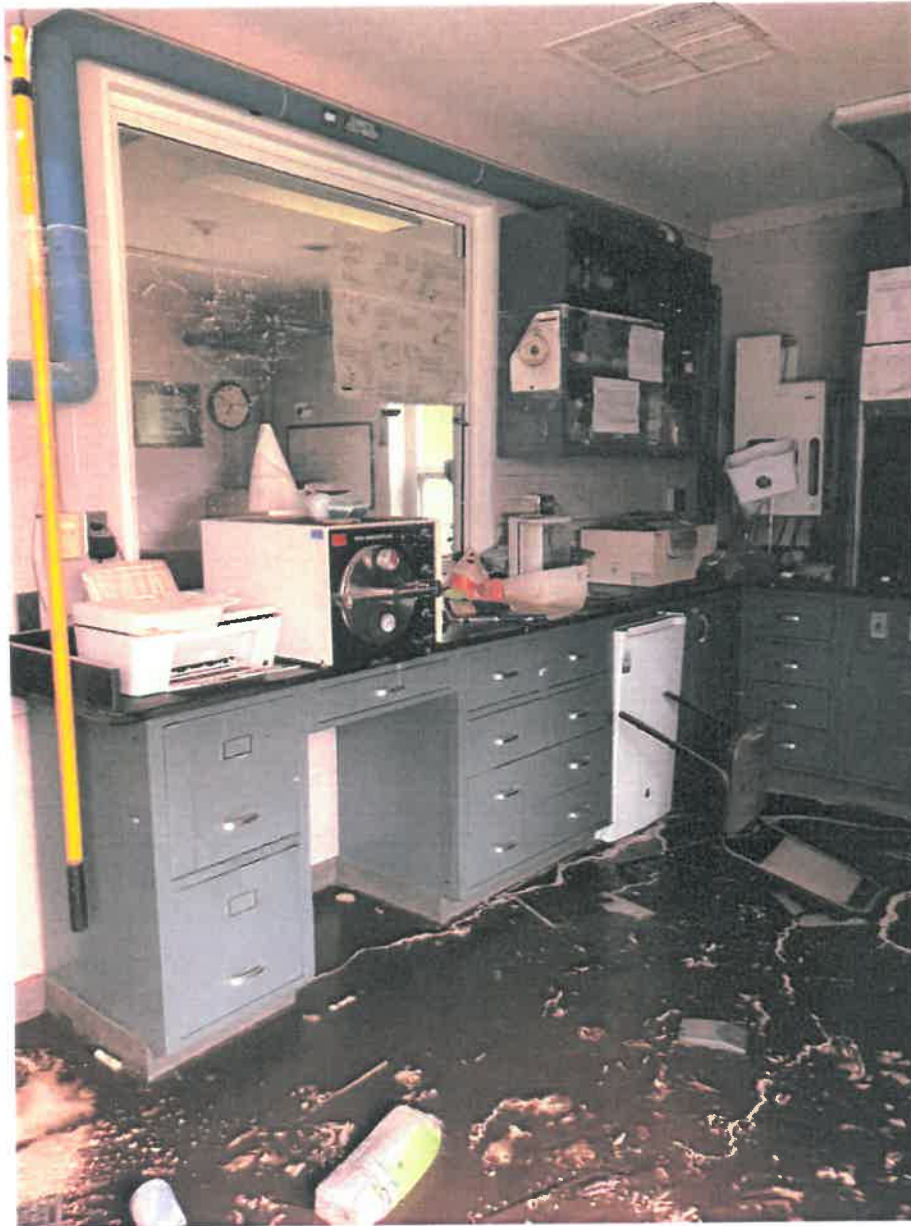
Except for the SBR actuators and belt filter press, the entire plant was inundated and submerged with flood water. High water marks were observed near the top of the ceiling mounted headworks ventilation blower, near the top of the top buckets of the MCC, near the top of the SBR control panel, and over halfway up the wall mounted lab cabinets (approximately 7-8ft)

2- High Water Mark in Laboratory Area

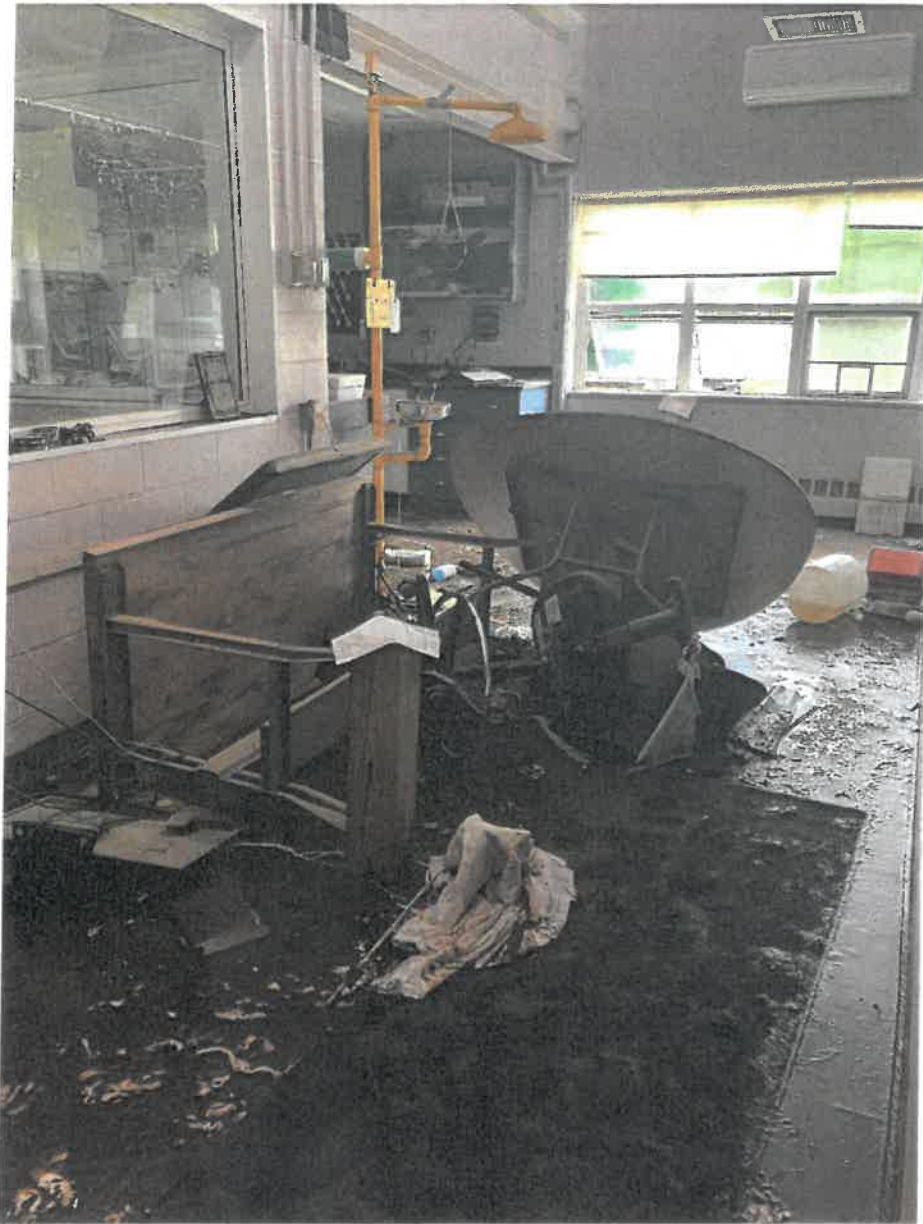
3- Post Flood Debris in Control Room

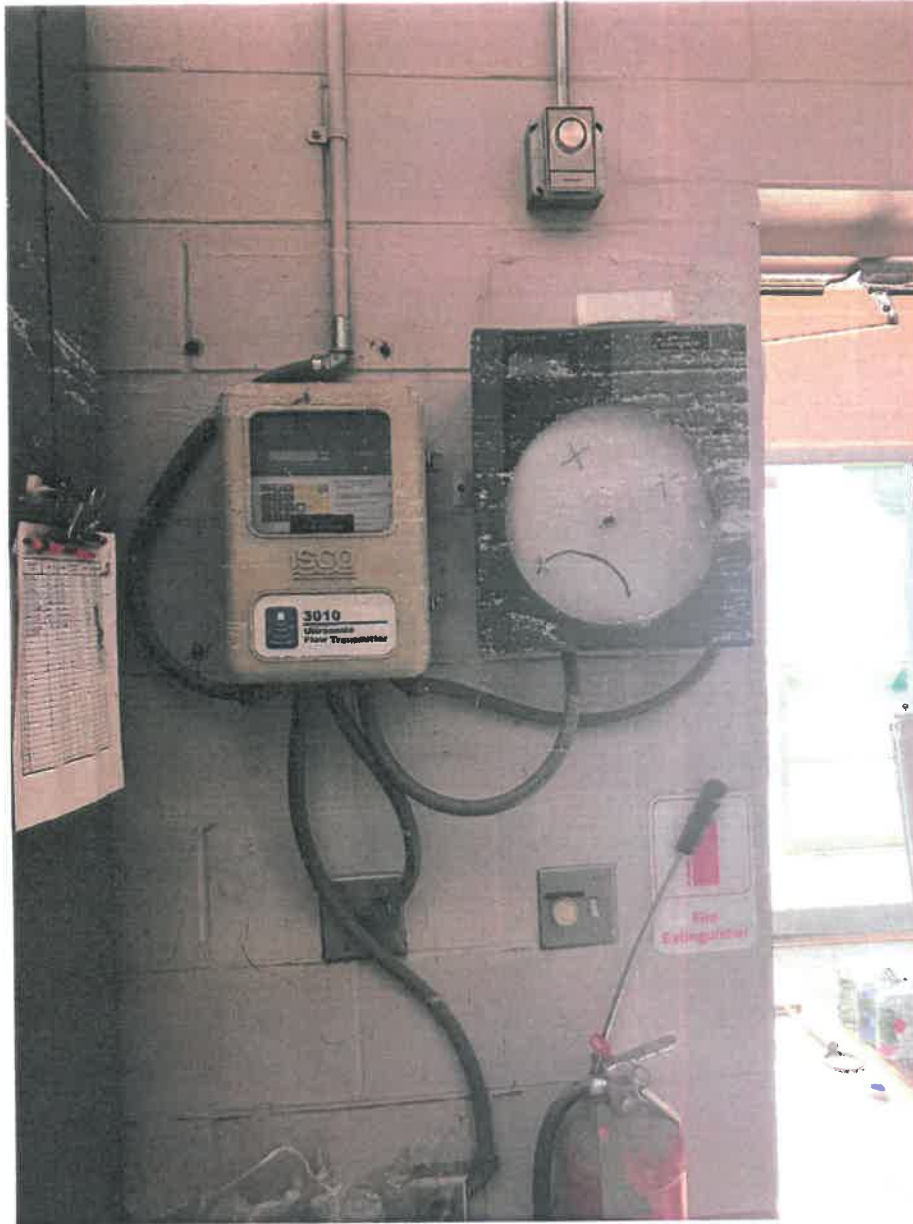
4- High Water Mark on Flow Meter and Chart Recorder

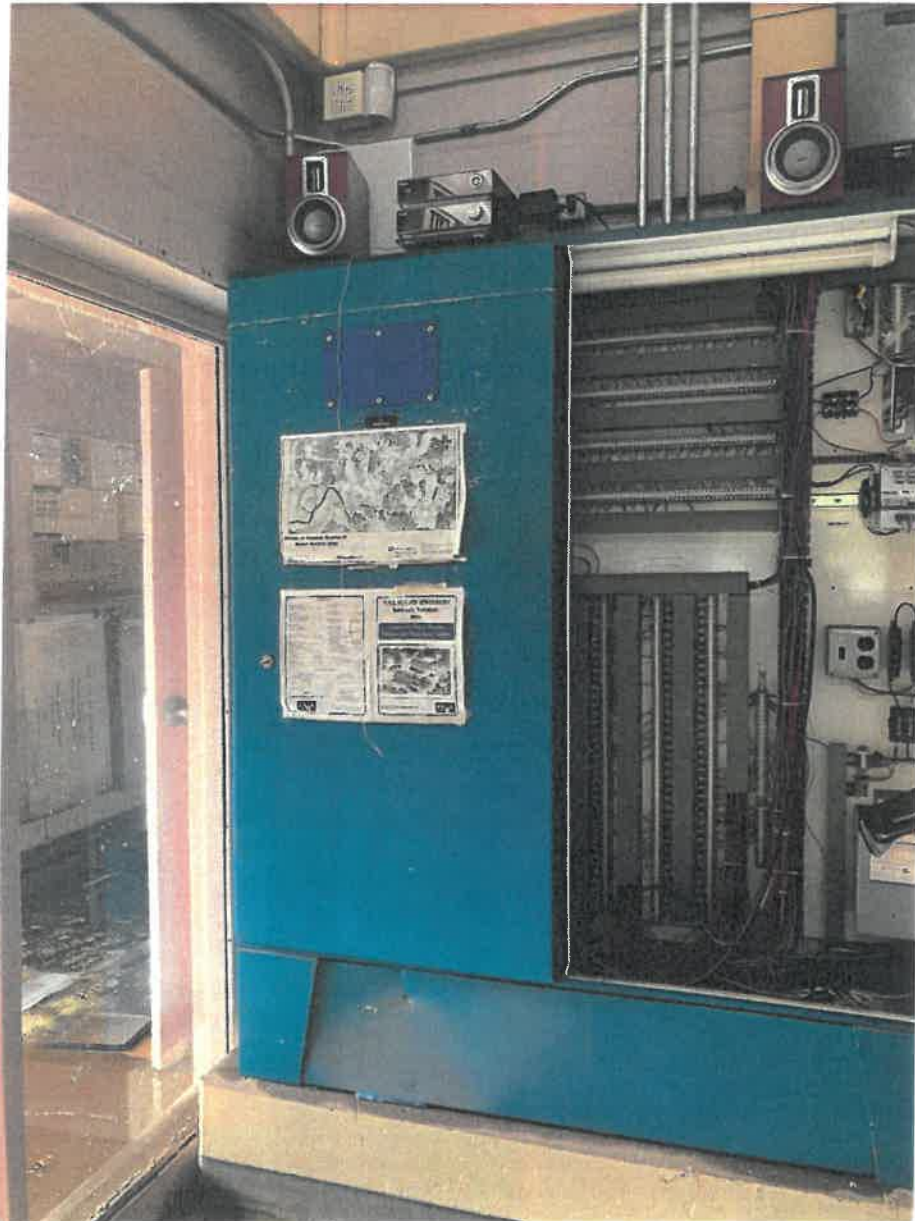
5- High Water Mark on Programmable Logic Controller (PLC) Cabinet

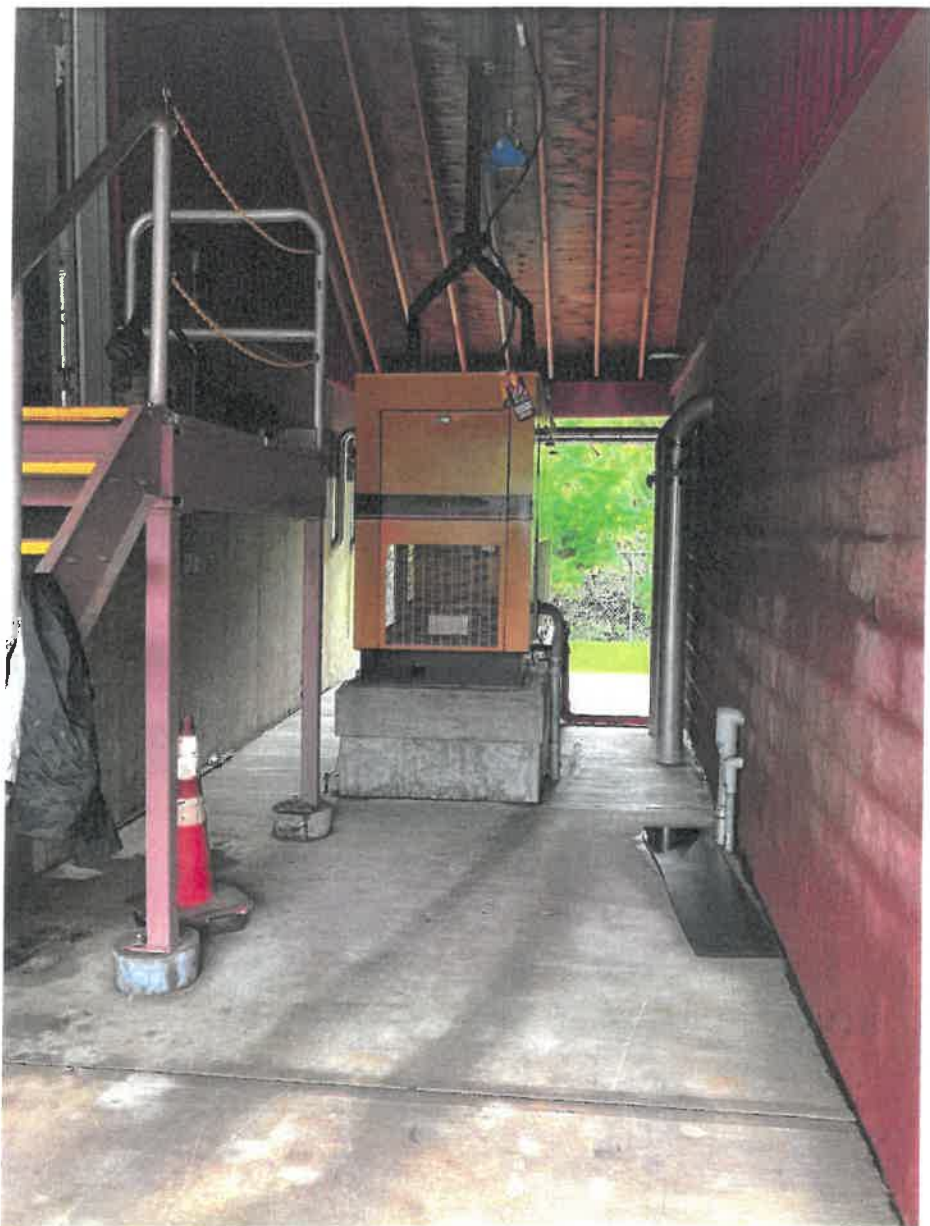
13- Plant Generator

switch (ATS), main SBR control panel, grinder hydraulic power pack, chemical feed pumps and tanks (alum and polymer), decant motors, and backup generator will also require complete re-build or replacement. The plant's lawn tractor with snow blowing attachments was also submerged in flood waters. The sludge press room (elevated) received minor inundation; high water mark was roughly one foot above the finished floor. Impact to the sludge press and its MCC is undetermined.

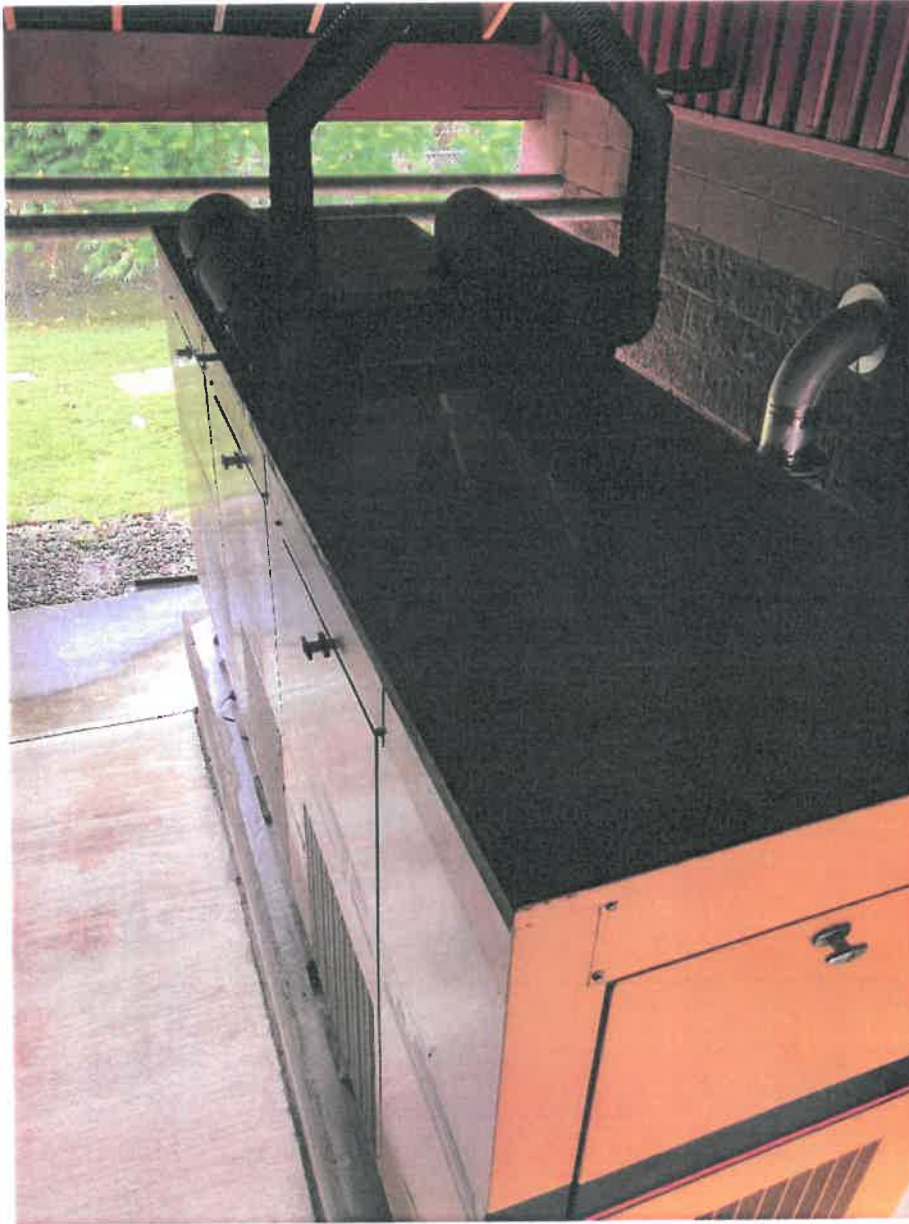
14- Plant Generator Top View Showing Residual Floodwater and Silt on Top

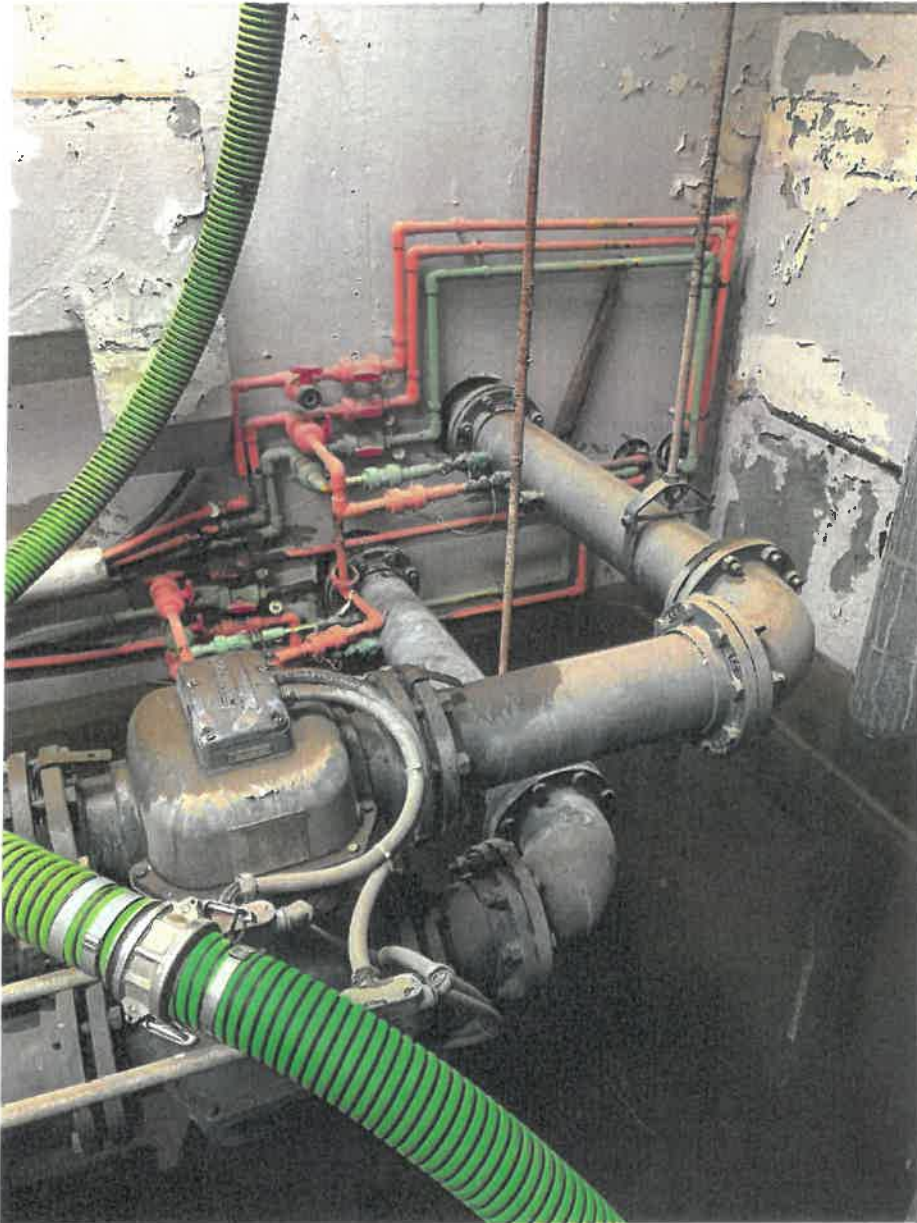
17-Influent Dry Well Piping with Influent Pumps Below Water Level

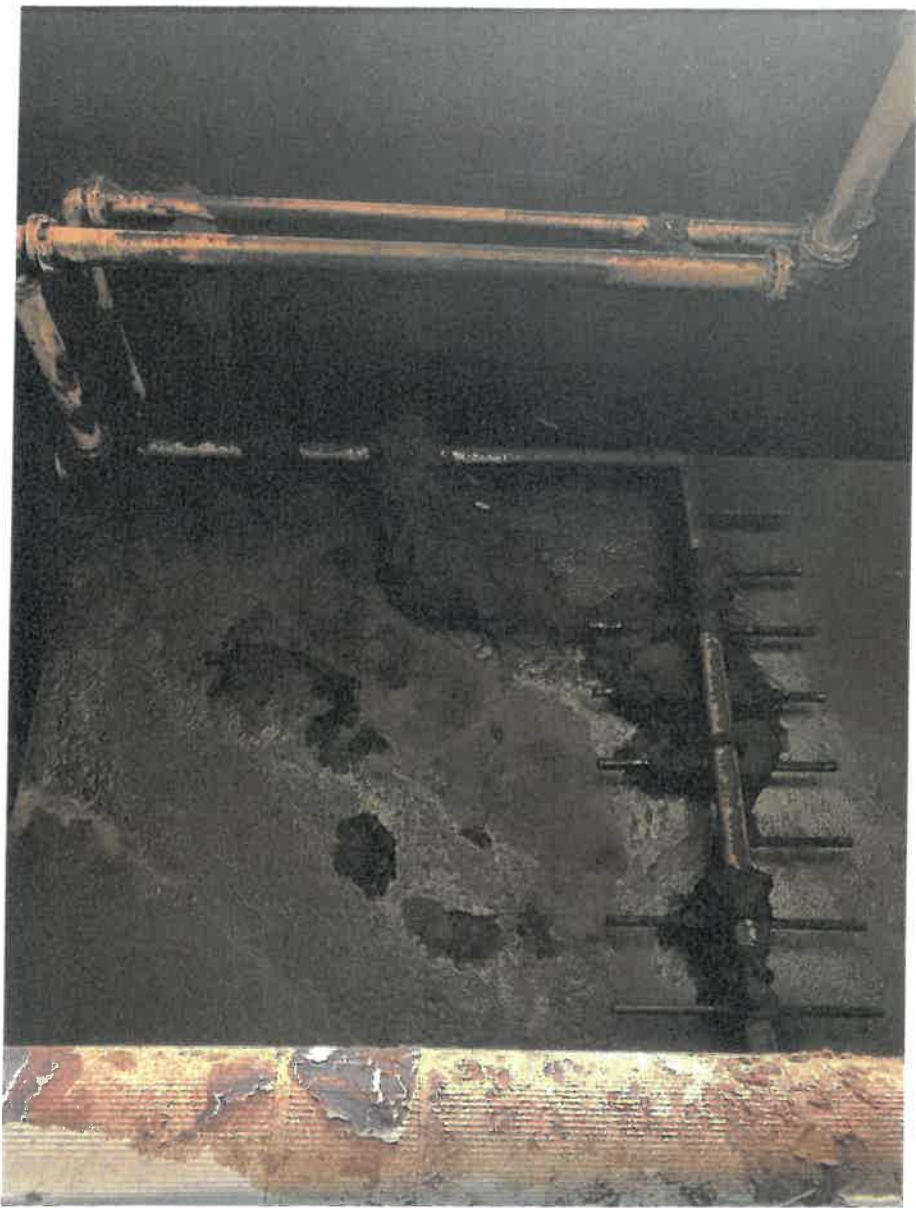
19- SBR Chamber After Pumping Out Flood Waters

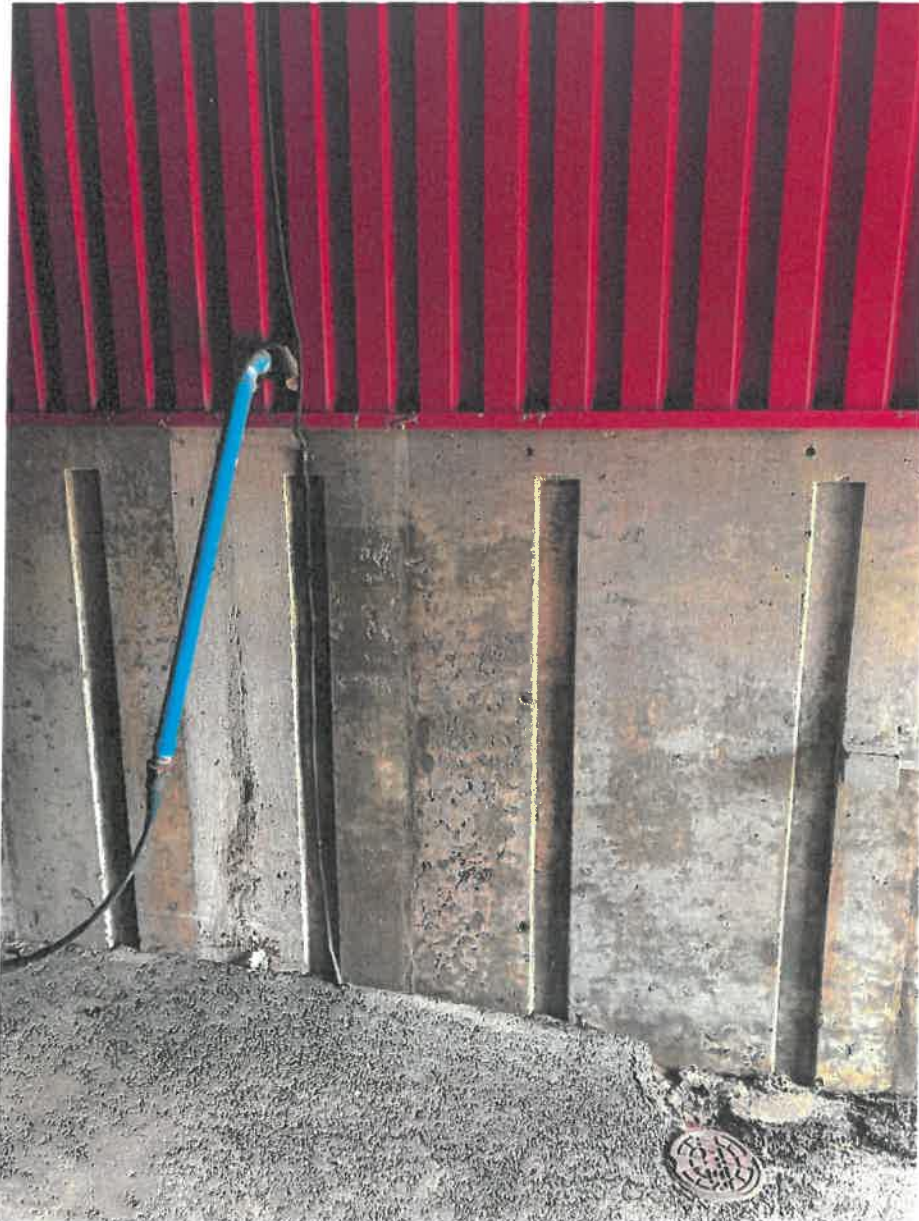
21- UV Building High Water Mark (Almost Even with Blue Pipe)

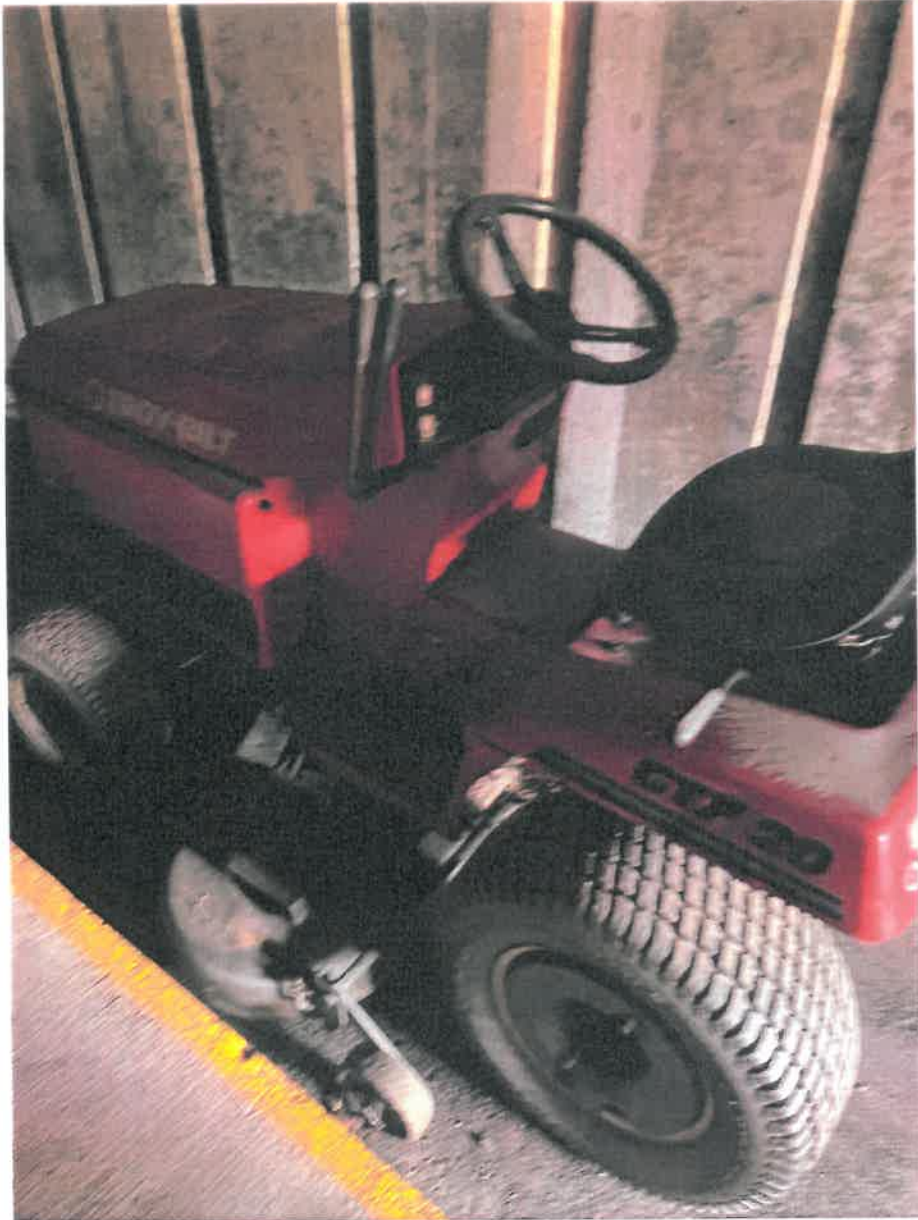
22- Lawn Tractor Stored in UV Building (Snow blowing Equipment in Front of Lawn Tractor Out of View) Note Silt on Top of Engine Cover From Being Completely Submerged

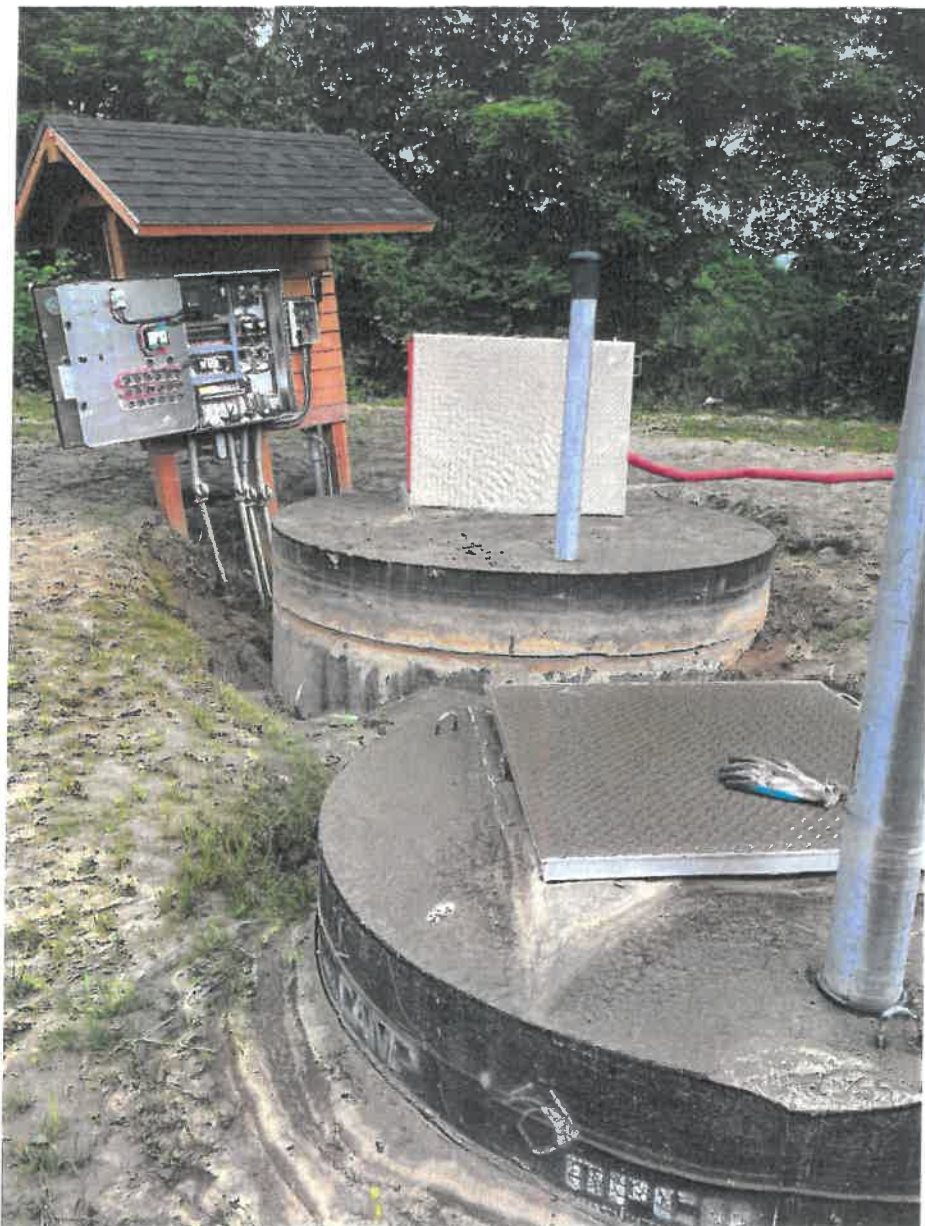
23- River Road West Pump Station

The main components of the wastewater pump station were left unharmed. Damage was limited to the partially submerged control panel, partially submerged remote monitoring system, electrical components, silt and debris accumulation, erosion around the site, tilting control panel mounting rack (due to erosion around post foundations), and likely damaged conduits. The wet well interior appeared unimpacted. The pump station was not operable during the site visits. A portable pump was in place and staff were manually operating the pump to pump off the decant to the Lamoille River while allowing solids to settle in the tank.

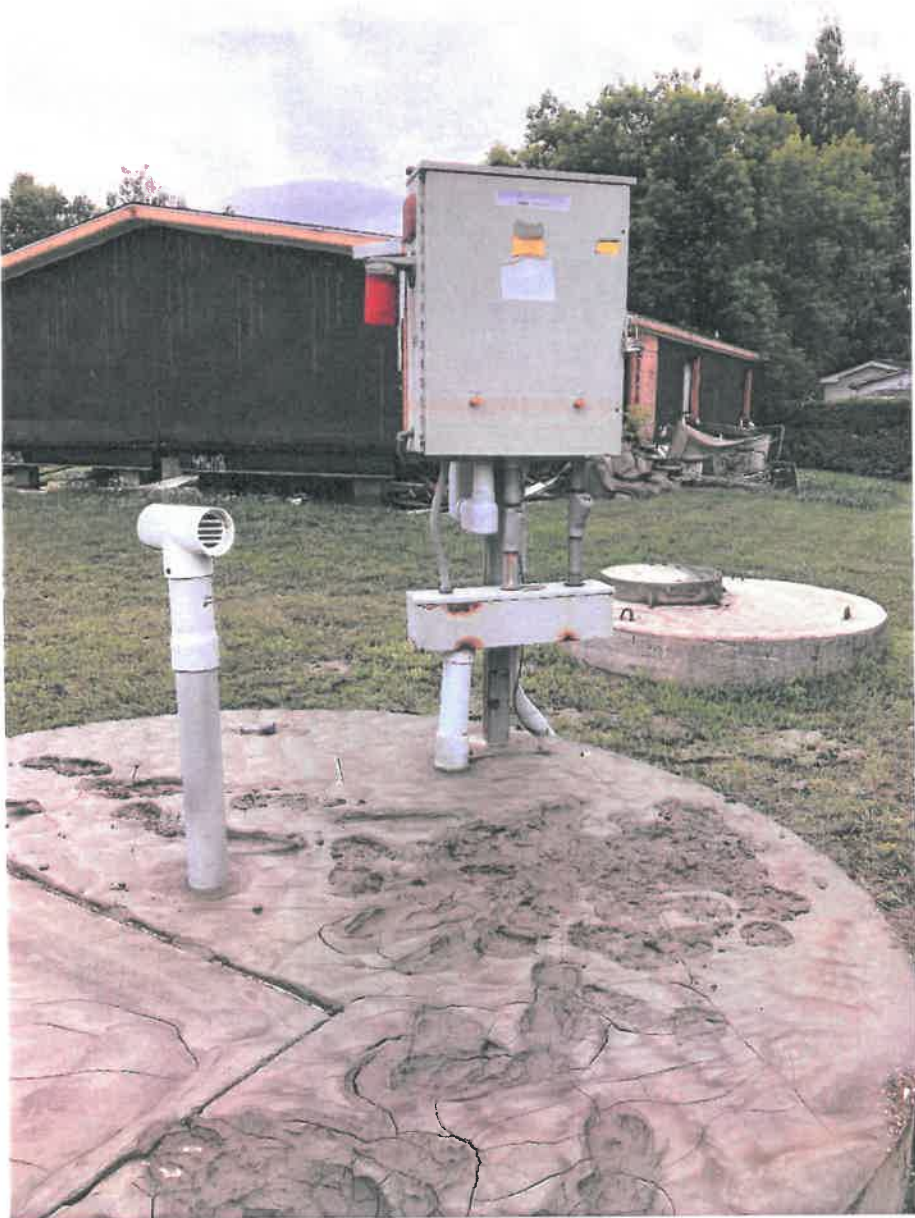
26- Highland Heights Pump Station

The main components of the wastewater pump station were left unharmed. Damage was limited to the partially submerged control panel, electrical components, silt and debris accumulation, and likely damaged conduits. The wet well interior appeared unimpacted. The pump station was back online and operable during the July 13, 2023, site visit.

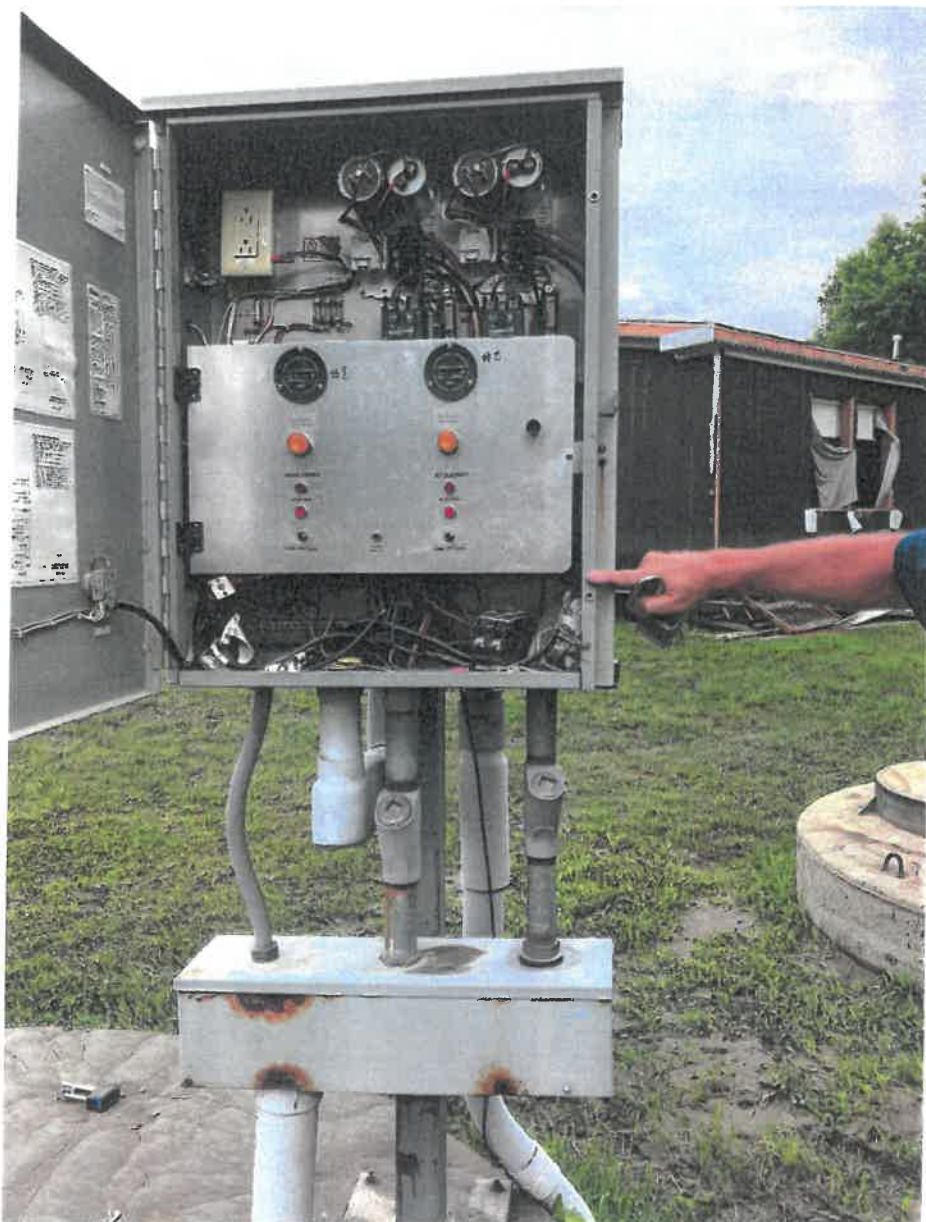
27- Highland Heights Pump Station Control Panel High Water Mark

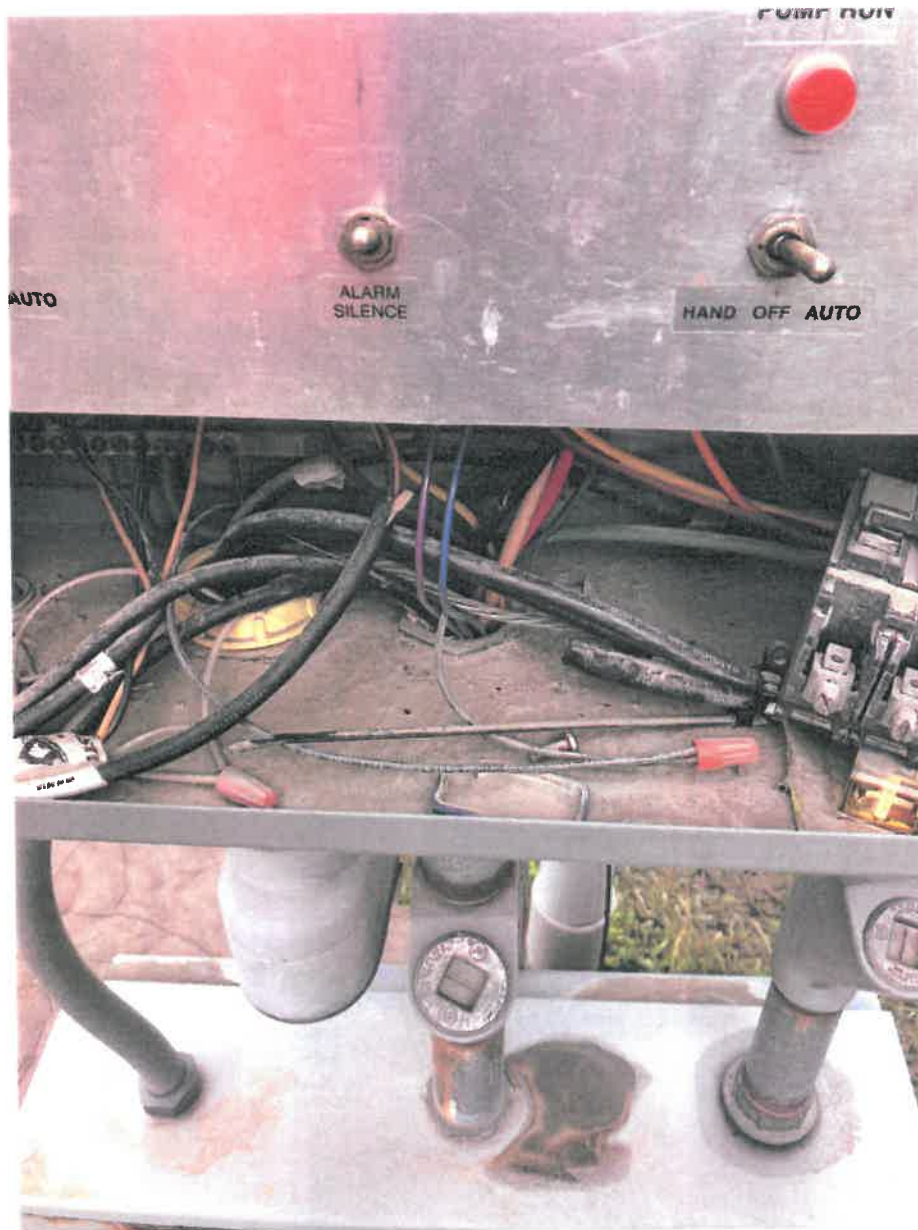
28- Highland Heights Pump Station Interior View with Residual Flood Water Silt

- An appreciable amount of grit and sediment from the upstream collection system inundation was likely conveyed into the wet well. Subsequently, pump performance should be checked for accelerated wear. Replace or recondition if found for both the River Rd. West and Highland Heights Pump Stations.

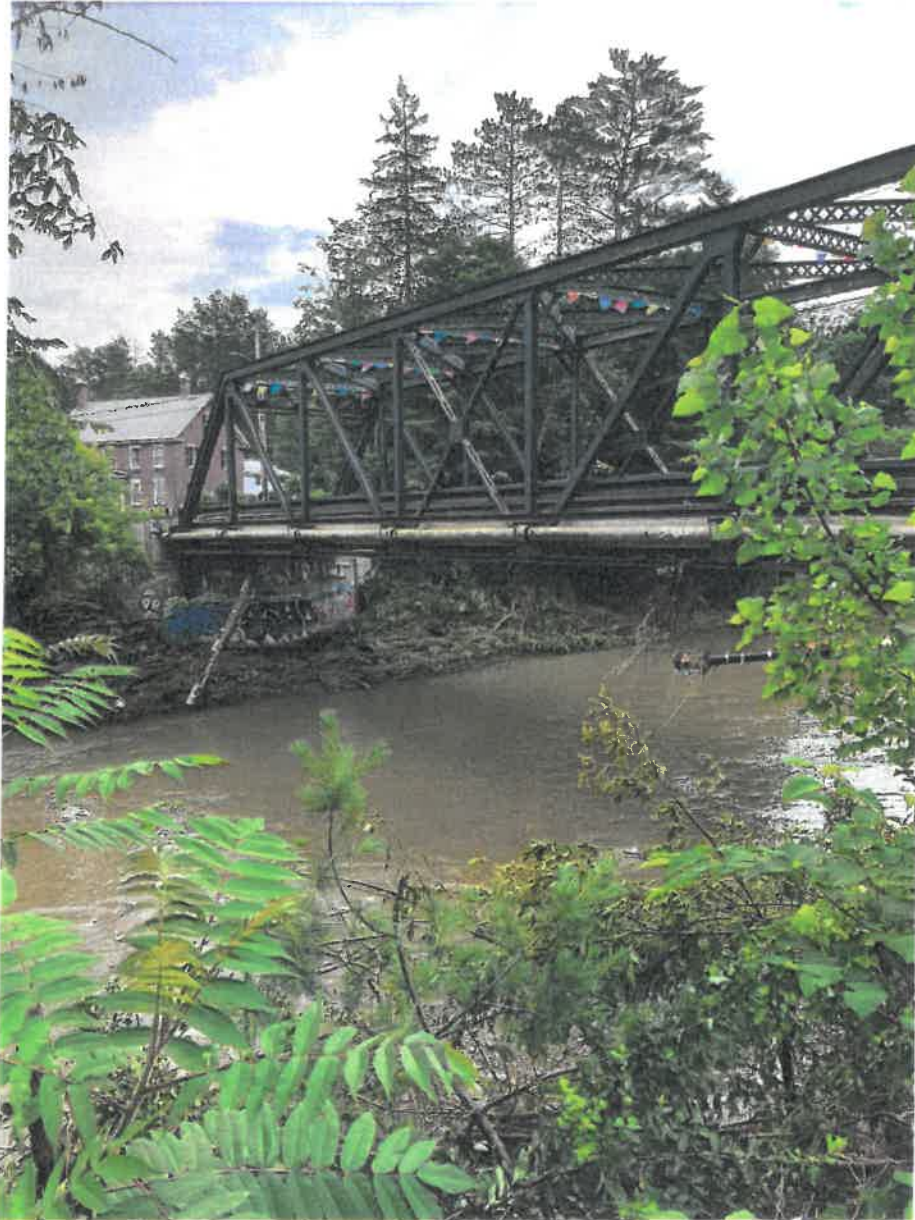
During the peak of the flooding a car floated down the Lamoille River and almost completely tore off the Railroad St Bridge 8" ductile iron sewer crossing. Most of the piping had been destroyed and was no longer present and most of the supports were significantly bent or missing. Flow was running directly into the Lamoille River.

29- Railroad Street Bridge Severed 8" DI Sewer Crossing

- Replacement of Railroad St. Bridge Crossing with in-kind pipe. Install more substantial pipe supports which would be more impact resistant.
- Jetting and camera inspection of low-lying collection system areas as the collection system received an appreciable amount of Grit/silt/debris. Camera inspections should be explored to ascertain collection system damages.

- Investigate possibility of replacing river crossing pipe with a depressed sewer / siphon type crossing. Installation of such an alignment may be difficult. It is questionable if sufficient horizontal setback is present to allow horizontal directional drill installation. The riverbed appeared rocky which would make open cut excavation slow and difficult. Furthermore, the appreciable vertical difference in the alignment could present regular maintenance problems due to solids accumulation if sufficient regular flow isn't present. This option requires further detailed investigation and consideration to determine feasibility.

- Investigate possibility of replacing the gravity line with a pump station and force main, with the force main suspended closer to road grade elevation, similar to the intact water main, thereby offering protection from the bridge structure. Adding a pump station to the system would however create an additional O&M expense and itself could be equally prone to flood damages. This option requires further detailed investigation and consideration to determine feasibility.
